MARINE INVESTIGATION REPORT
M02L0039

GROUNDING

GENERAL CARGO VESSEL *VAASABORG*
OFF ÎLE DE GRÂCE, QUEBEC
22 MAY 2002

Report Number M02L0039

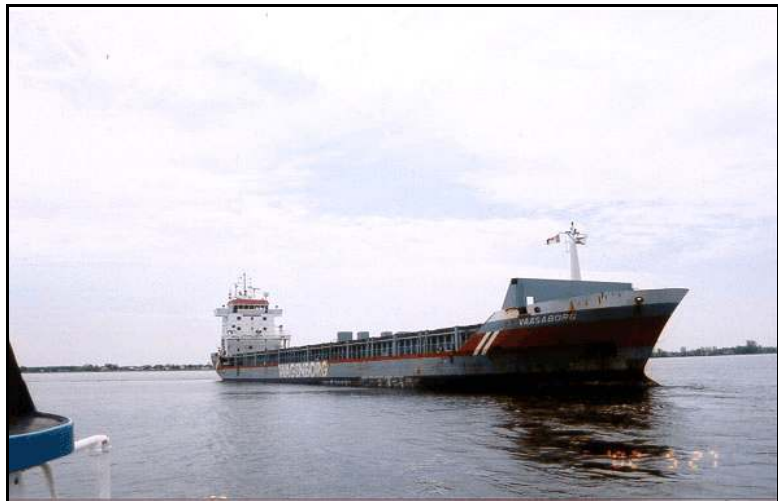
Attempts to refloat the vessel were not successful until the vessel had been lightened, and on 29 May 2002, the *Vaasaborg* was refloated. No pollution, injury, or major damage resulted from this occurrence.

Photo 1. *Vaasaborg* aground. The vessel was refloated after lightening the cargo by some 1800 metric tons.

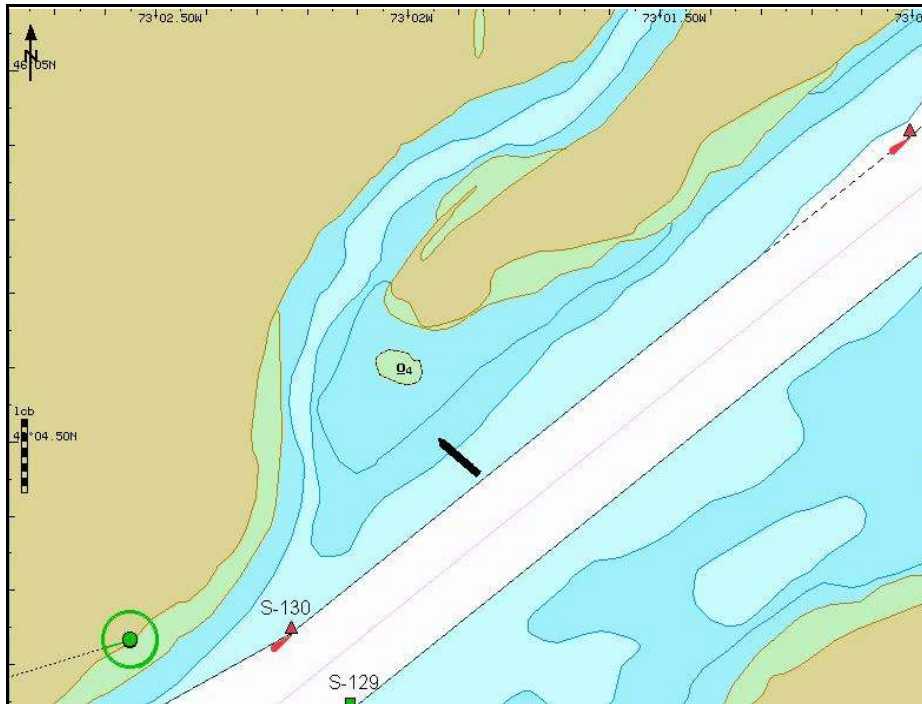
Figure 1. Sketch of the area of grounding

The pilot put the engine-telegraph astern. The master was in the ship's office and felt the vessel list to port. He immediately ran to the bridge. Upon his arrival, he saw the rudder angle indicator showing that the rudder was moving from hard-a-starboard to port; he put the engine-telegraph to zero (stop) and then astern. The master ordered the OOW to go to anchor stations. Notwithstanding these actions, at approximately 1005, at a speed over the ground of 11.6 knots, the vessel ran aground outside the north side of the channel, off Île de Grâce. The vessel came to rest in position 46°04'30" N, 073°01'54" W, on a heading of 310.5° Gyro (see Figure 1 and Appendix A).

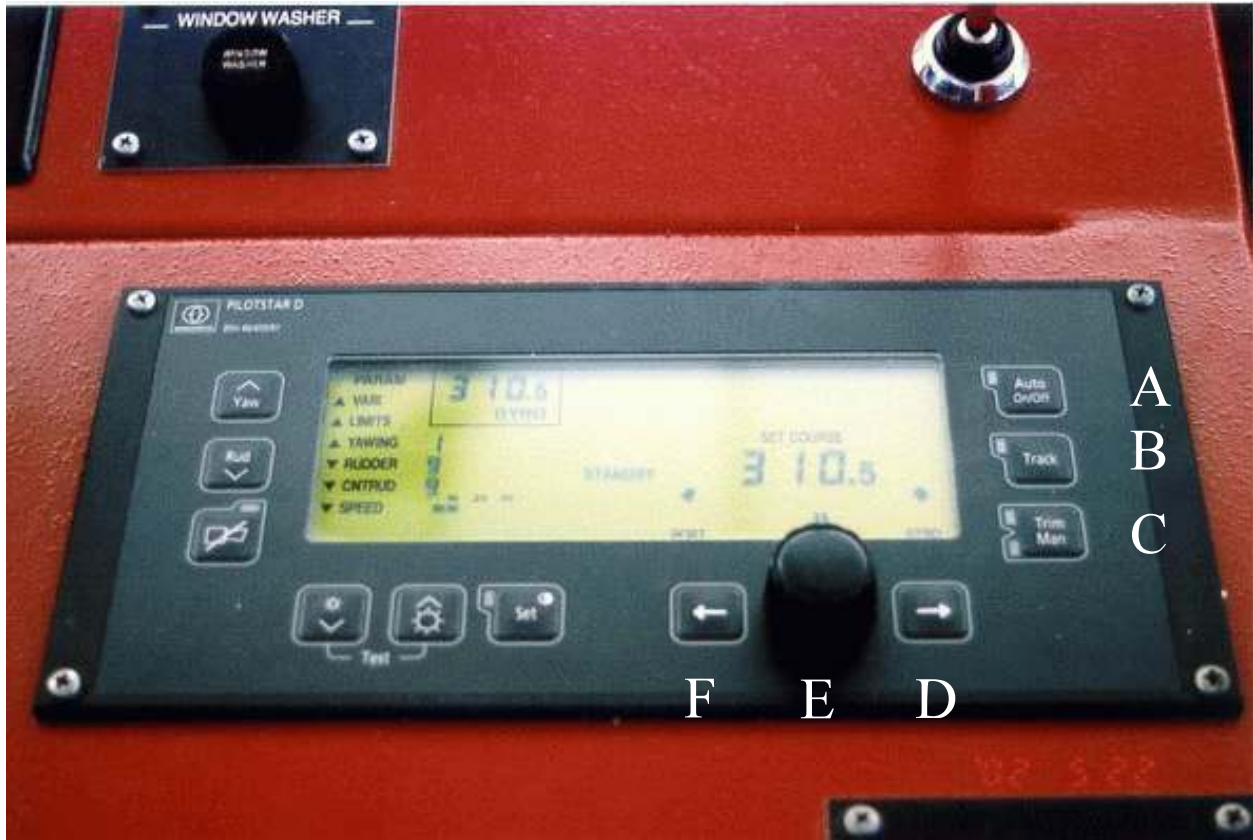
Photo 2. Autopilot control panel

On the Pilotstar D autopilot control panel, the “Auto On/Off,” “Track” and “Trim Man” function membrane keys are identical in size and touch as the arrow (course alteration) keys. The proximity of the “Trim Man” function key to the starboard arrow key and the vessel’s behaviour in the events leading up to the grounding suggest that the pilot inadvertently pushed the “Trim Man” key instead of the starboard arrow key, just prior to the vessel turning abruptly to starboard.

By pushing this function key, the autopilot was deactivated, the system changed to manual control and to NFU mode. In manual and NFU mode, the set course reading is deactivated and the reading does not change. All further attempts to correct course to steer, using the arrow keys, were now actual rudder commands. The sequence of events indicates that the actions of the pilot to regain control of the rudder and steer 230° were in fact now causing the rudder to move increasingly to starboard. This is consistent with the vessel’s rapid swing to starboard and would account for the 80° deviation of the course.

1. No crew member of the *Vaasaborg* was tasked to steer the vessel, and the pilot undertook to make course set alterations with the autopilot.
2. In trying to change the set course, it is most likely that the pilot inadvertently first pushed the “Trim Man” function key instead of the starboard arrow (course alteration) key, thereby deactivating the autopilot and switching the system to the non-follow-up mode.
3. When the pilot pressed the starboard arrow key, the helm gradually turned to hard-a-starboard, but the course set reading on the autopilot screen remained the same.

Upon receiving MSI 08/02, the LPA communicated with the Port of Montréal (District No. 1.1) pilots and the two pilot corporations, i.e. Montréal-Québec (District No.1) and Québec-Les Escoumins (District No.2), recommending that the pilots not steer the vessel themselves using an autopilot, but instead request the services of a qualified helmsman. The LPA insists that a qualified deck watch officer and helmsman from the ship's complement be in the wheelhouse in compulsory pilotage waters to steer the vessel.
